## R.F. Mitall & Associates, Inc.

Re: Municipal Building

As you requested, R. F. Mitall & Associates, Inc. has conducted a visual inspection of the brick facade on the portion of the municipal building housing the council chambers.

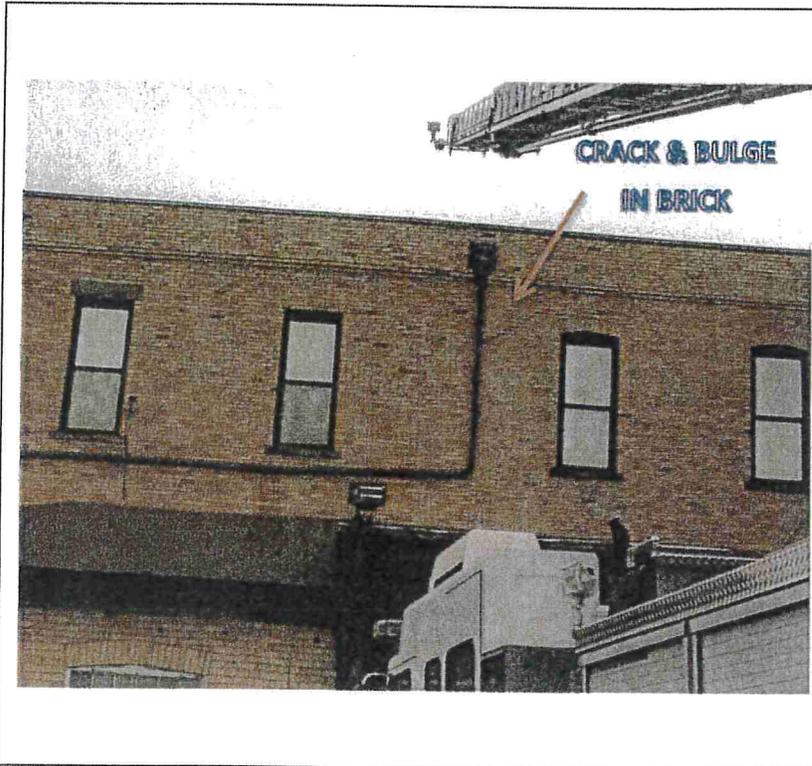
**PHOTOGRAPH #1**

2<sup>ND</sup> FLOOR ENTRANCE ABOVE GARAGE  
(LEFT SIDE OF COUNCIL CHAMBER)

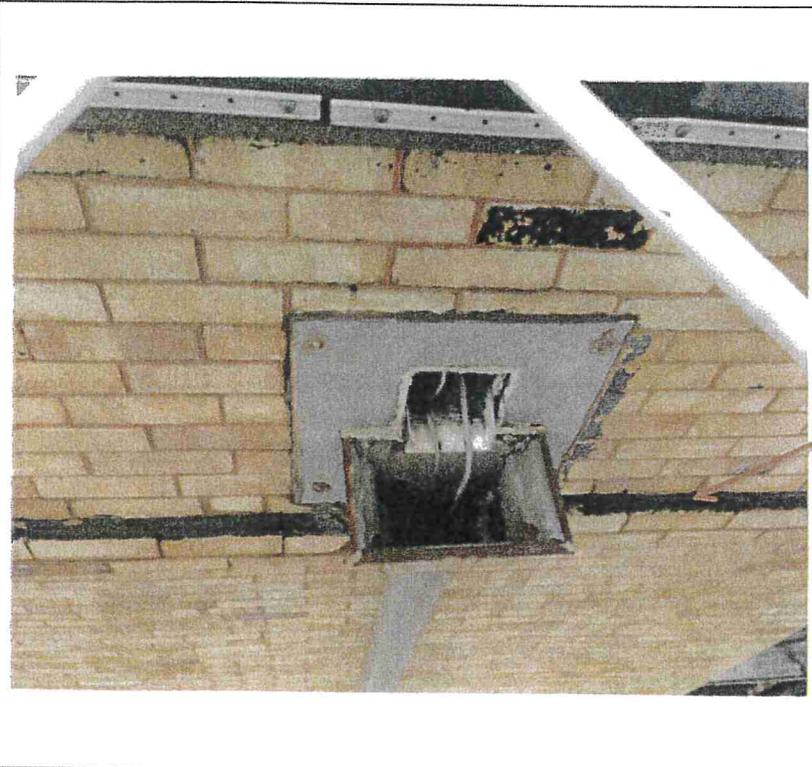
**PHOTOGRAPH #2**

SCUPPER ABOVE GARAGE

**BRICK DISPLACED**

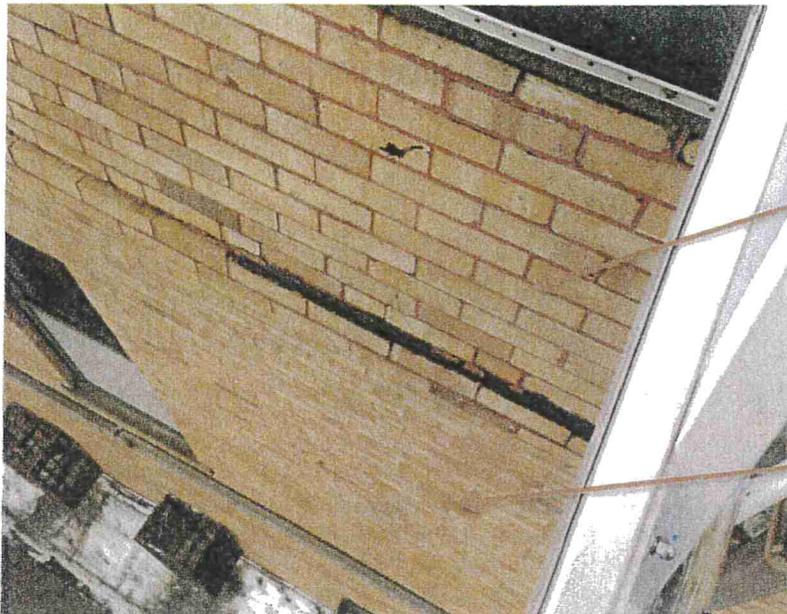
**PHOTOGRAPH #3**

WALL ABOVE GARAGE

**PUSHED BRICK**

**BULGING WALL**

1. Barricade off the sidewalk and parking area adjacent to Roslyn Street where the brick is leaning inward. This should be a solid barricade or fence that would prevent debris from bouncing into the street in the event of a failure.
2. The garage area beneath the left side bulging brick veneer should be cordoned off with no occupancy or transit allowed since a wall collapse could penetrate or comprise the garage roof.
3. As the advent of cold weather is imminent, a competent roofer should make emergency repairs to the roof and drains to eliminate the possibility of more water entering the building structure.
4. Lastly the borough should consult with a masonry restoration firm to decide if the brick veneer should be removed and relayed or if wall anchors would prevent the brick veneer from falling.

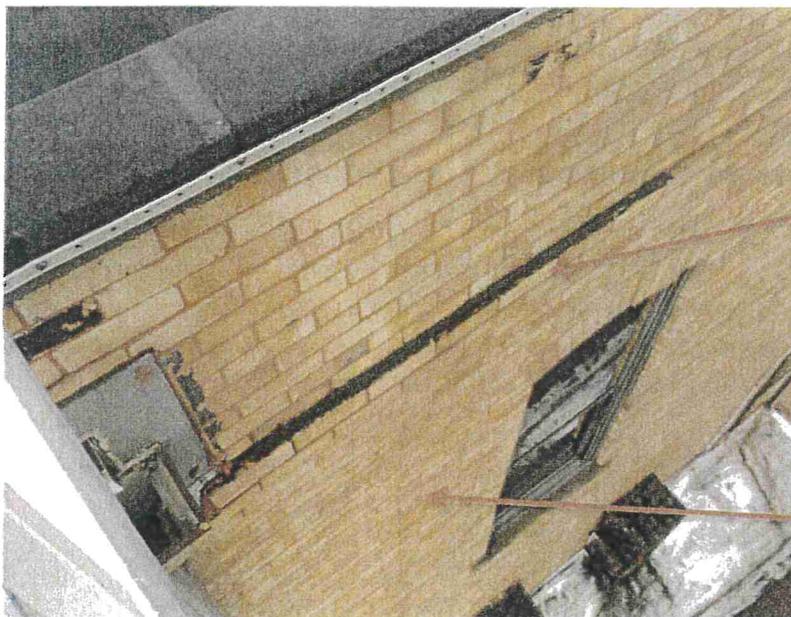
**PHOTOGRAPH #4**

EXTERIOR WALL ABOVE GARAGE

**DISPLACED BRICK**

**BULGING WALL**

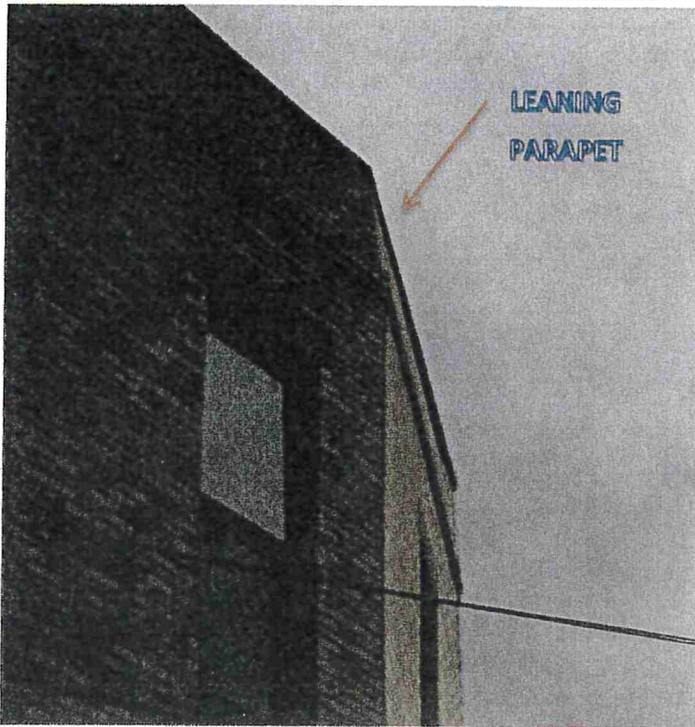
PHOTOGRAPH #5

ROSLYN STREET EXTERIOR TOP  
OF WALL

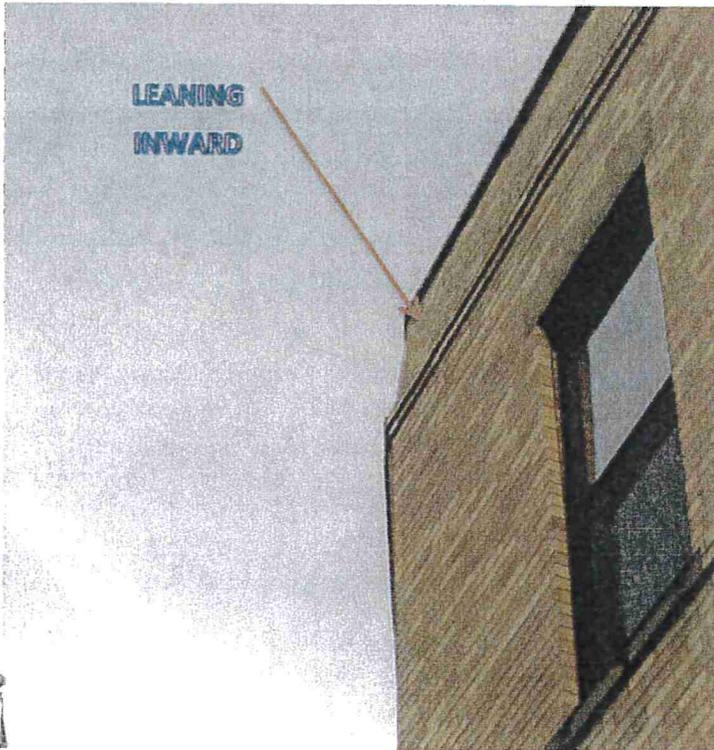
PHOTOGRAPH #6

ROSLYN STREET EXTERIOR TOP  
OF WALL

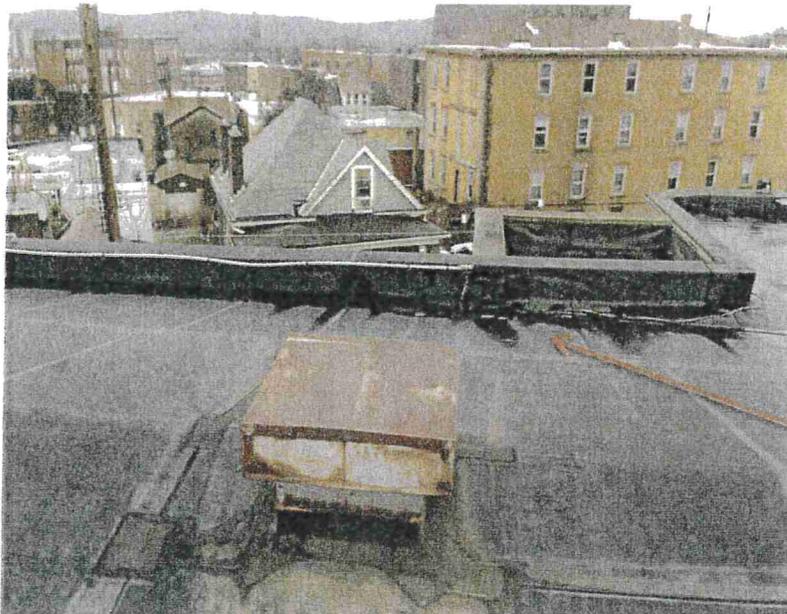
**PHOTOGRAPH #7**

It was noted by observing the roof from the fire truck ladder that there was standing water on the roof near the two scuppers (roof drains). It was also noted that the various wood roof members were water stained or damp, and in one area water droplets were hanging from the roof rafters.

ROOF ABOVE ROSLYN STREET

**POND OF WATER  
NEAR SCUPPER**

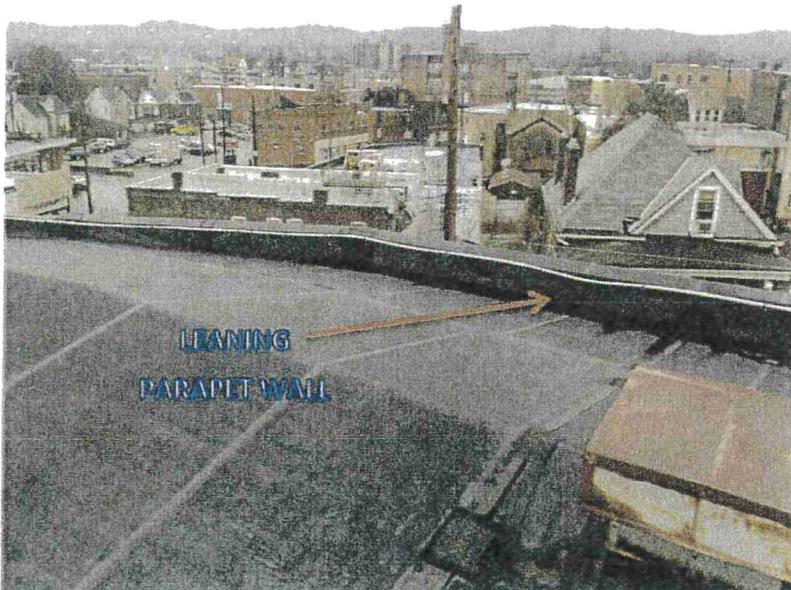
**PHOTOGRAPH #8**

ROOF ABOVE ROSLYN ST.

**LEANING  
PARAPET WALL**

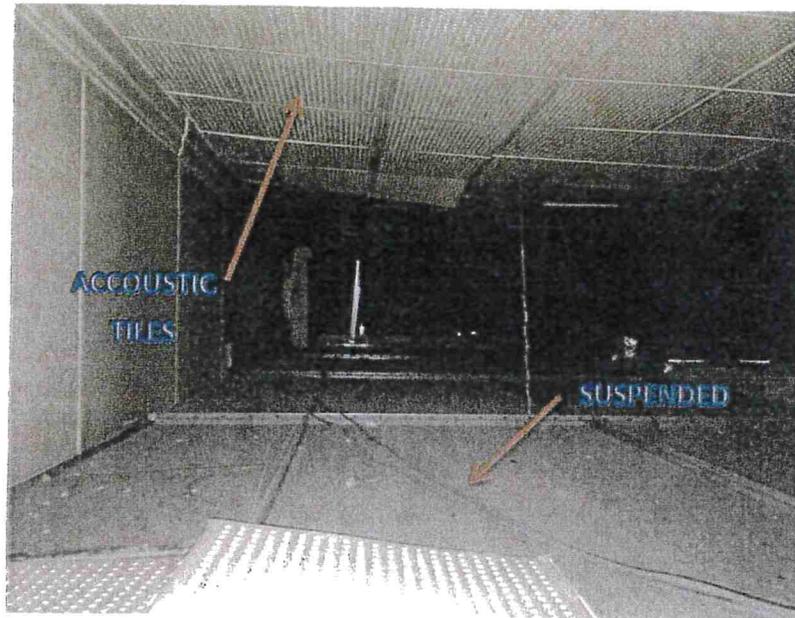
**PHOTOGRAPH #9**

INTERIOR SHOWING DOUBLE  
CEILING

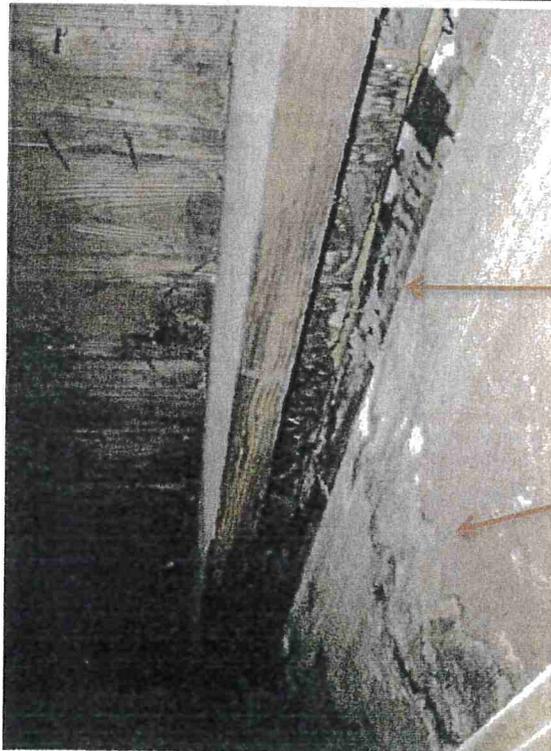
**PHOTOGRAPH #10**

WATER STAINED & DAMP  
CEILING JOISTS

**DAMP WOOD**

**WATER STAINS**

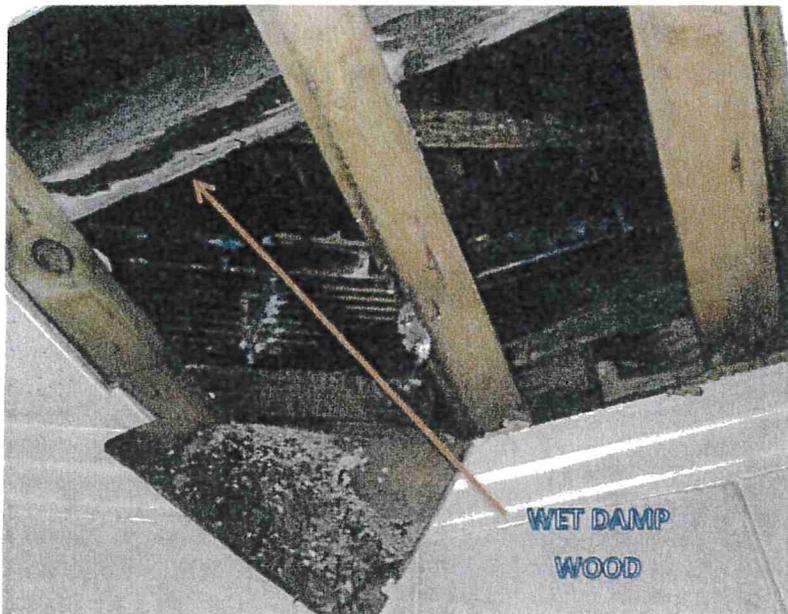
PHOTOGRAPH #11

INTERIOR ROAD ABOVE ROSLYN

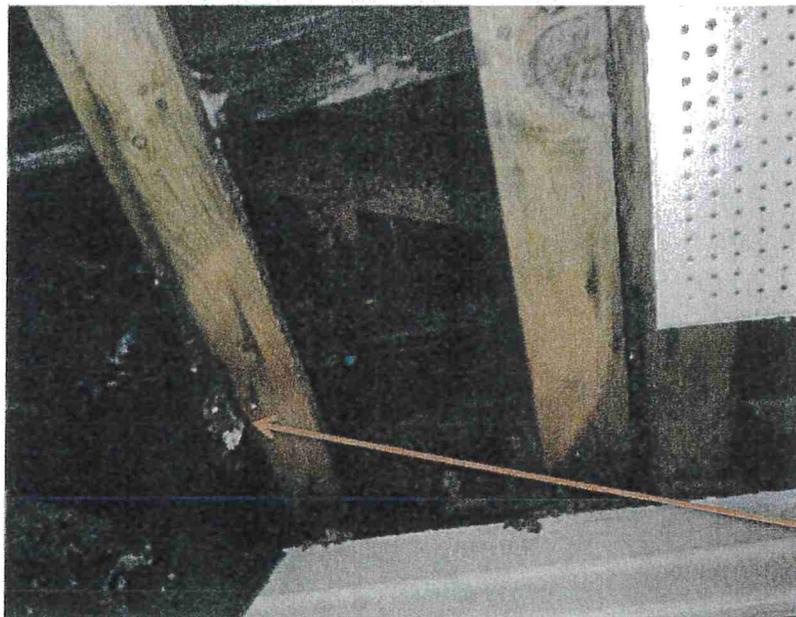
PHOTOGRAPH #12

INTERIOR CEILING

DRIPPING  
WATER

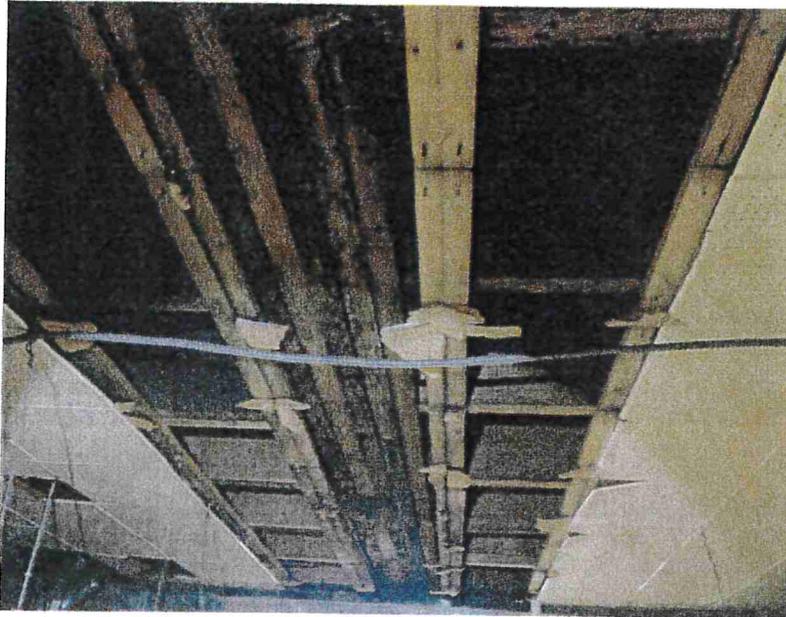
**PHOTOGRAPH #13**

WOOD TRUSS (BUILT UP 2010)

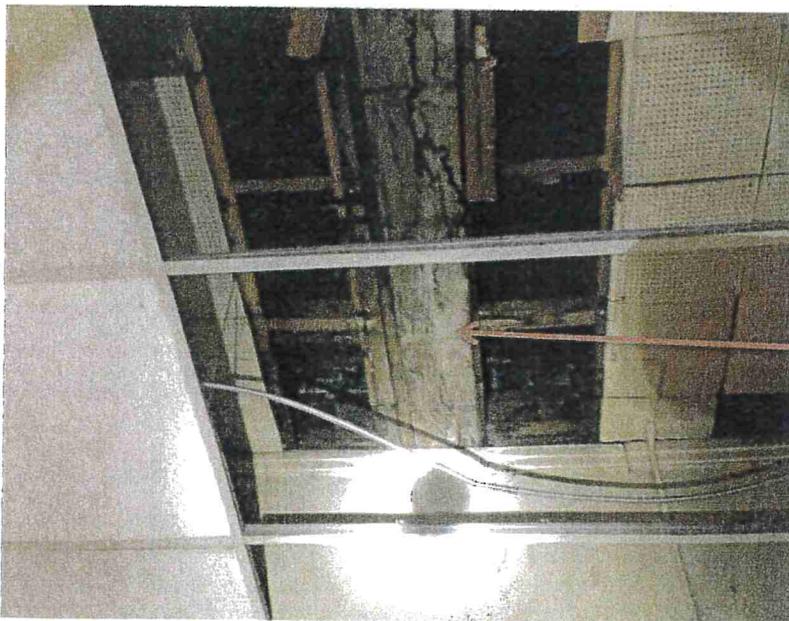
**PHOTOGRAPH #14**

INTERIOR CEILING

**WATER STAINED  
DAMP WOOD  
FRAMING**

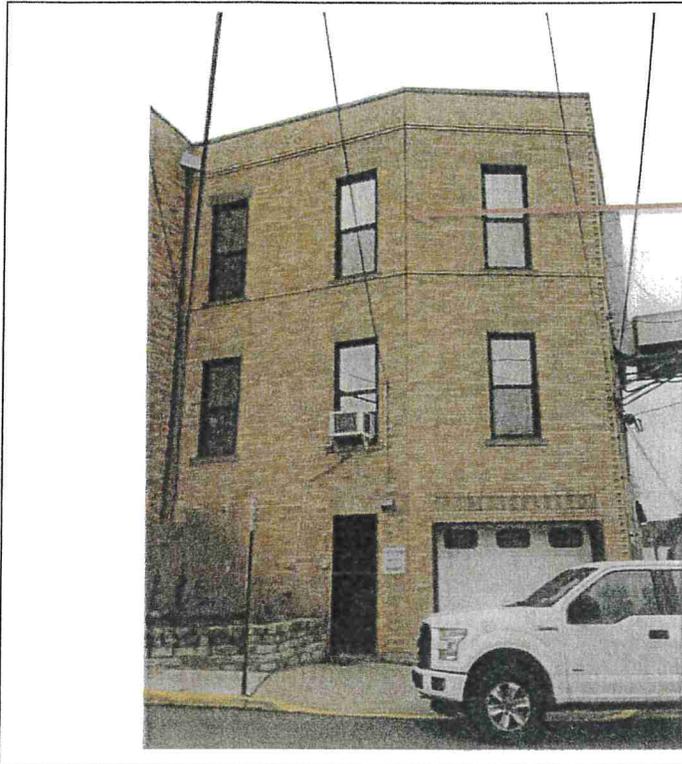
PHOTOGRAPH #15

ROSLYN STREET SIDE

**VERTICAL  
SEPARATOR AT  
CORNER**
