March 27, 2019

Mr. Gregory Bachy
Borough of Swissvale
7566 Roslyn Street
Pittsburgh, PA 15218

Swissvale Borough Building Structural Inspection

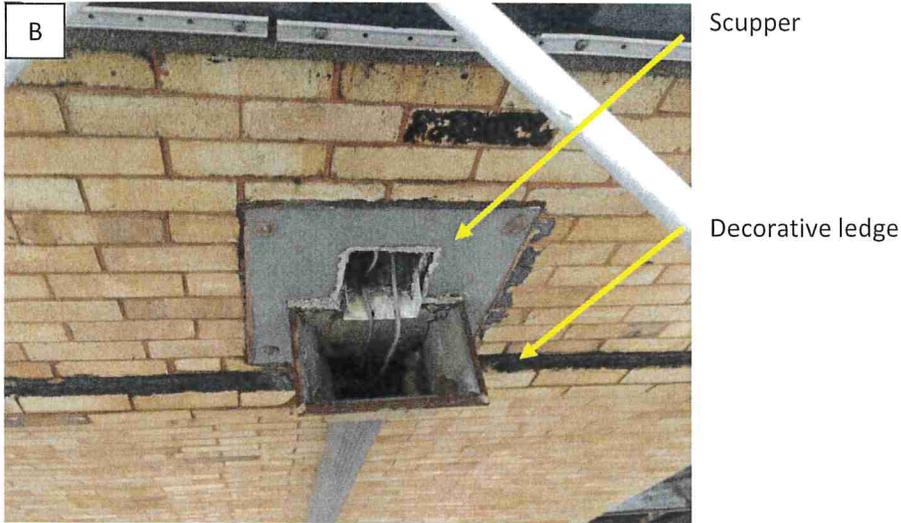
December 2015

The eastern wall of the council chambers appears to be moving and unstable. The photographs from 2015 and 2019 are below. Although not taken from the same vantage point, the 2019 photograph shows significant movement in the brick façade near the scupper between the second and third window.

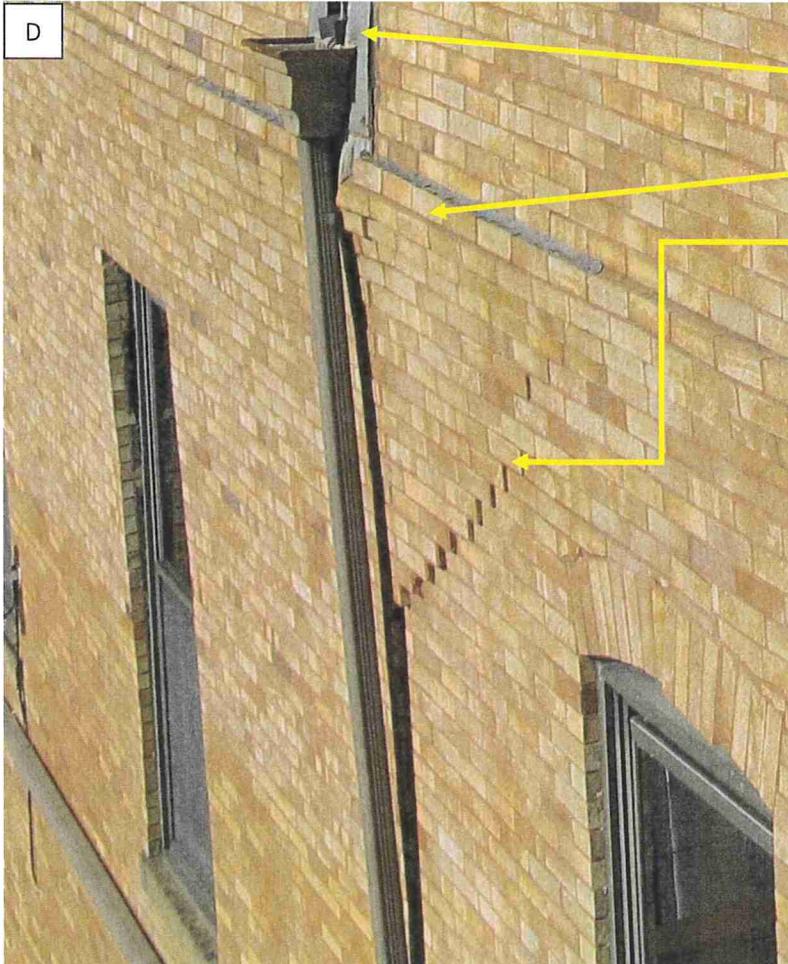
March 2019

Scupper

Substantial movement of brick

Diagonal crack worsened

It appears the leaning of the brick façade is now combined with the movement of the parapet.

It is plausible that given a large enough wind gust or severe weather, a large section of this façade could fall through the roof below. It is recommended that the portion of the Public Works Garage under this roof be not used until the façade is made safe. Additionally, vehicles should not be parked or worked on in the garage below this roof. To help minimize damage to the garage roof below, it is recommended that ¾ inch plywood panels be laid on the top of the roof in the "fall area" of the brick facade. This will not completely protect the roof from catastrophic damage, but may mitigate damage.

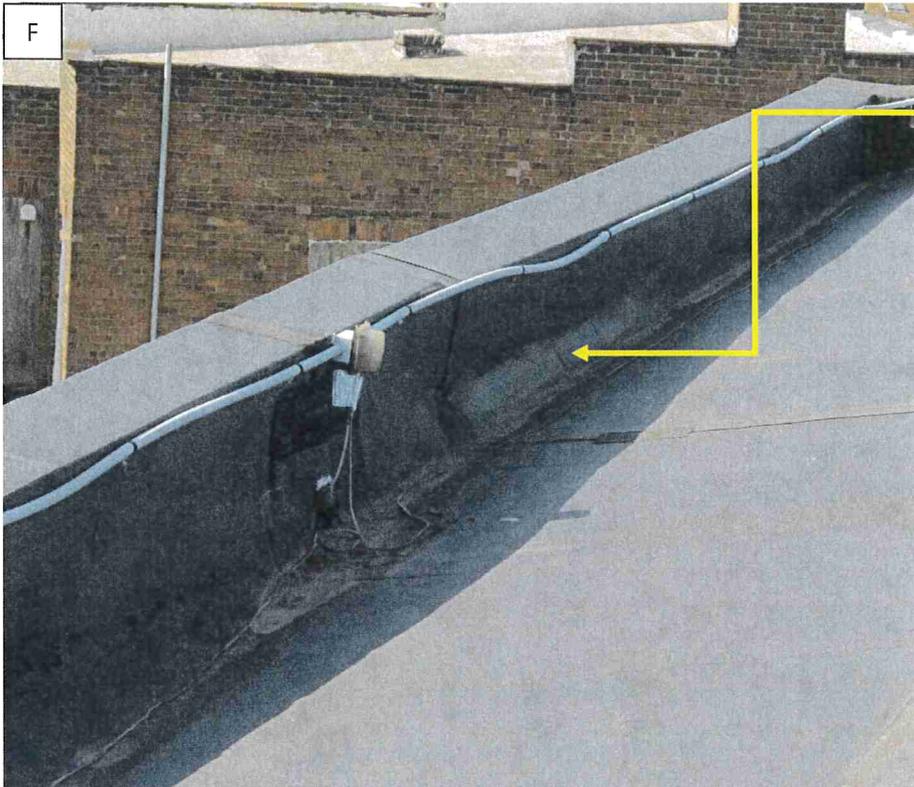
Roof membrane stretched due to parapet movement

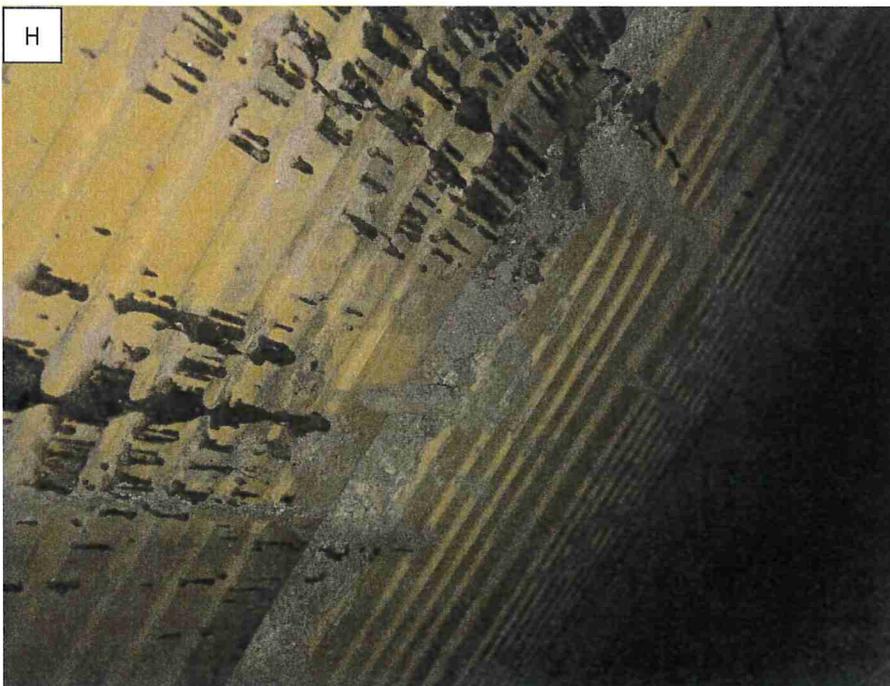
This is a photograph of the back side of the clay tile structural wall. The tar from the roof repair (approximately 20 years ago) can be seen as well as deteriorating mortar. This clay tile was installed approximately more than 80 years ago. Moisture and lack of ventilation expose this material to moisture. As researched from (next page)

Due to the movement and cracking of the upper levels of the building facade, it no longer provides protection against water infiltration. During the inspections, evidence of water infiltration was noted in multiple locations throughout the building. Introducing moisture into the area of the structural tile is a potentially serious issue that could affect the structural integrity of the building.

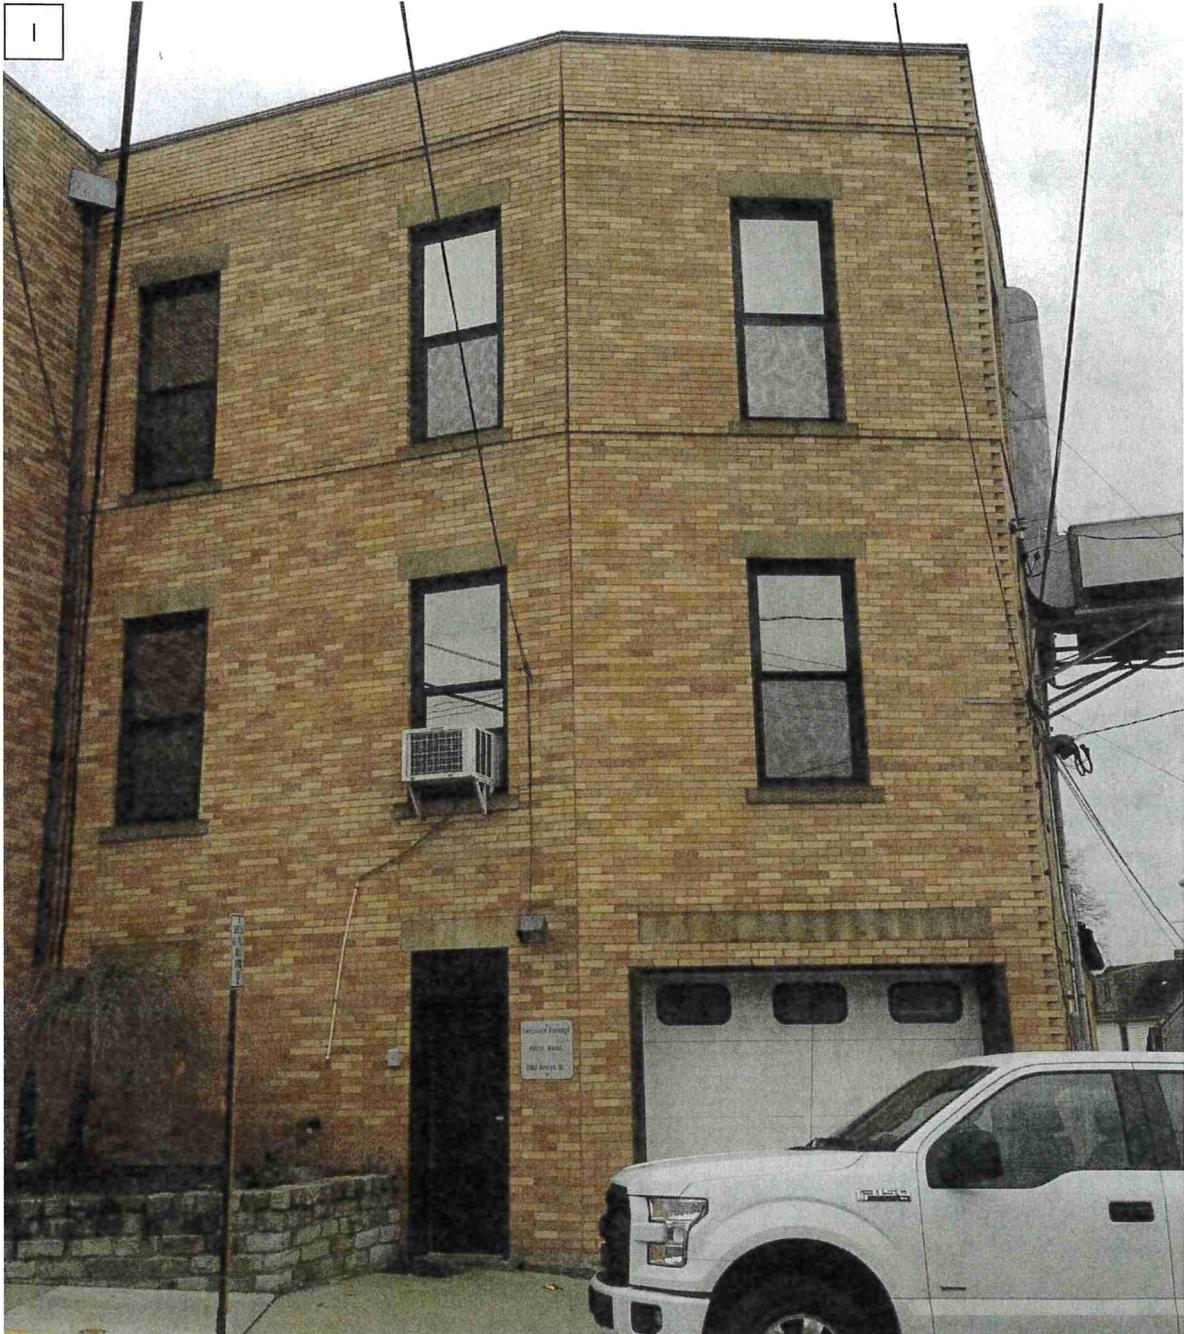
December 2015

This photograph shows the west side of the building during the 2015 Inspection. Note that parapet appears to be slightly bulging out at the decorative ledge. Swissvale Borough had a wall anchor service install a series of plates and tie backs (photo prior to their installation). There is also a separation of the brick joint vertically with the widest portion at the decorative ledge.

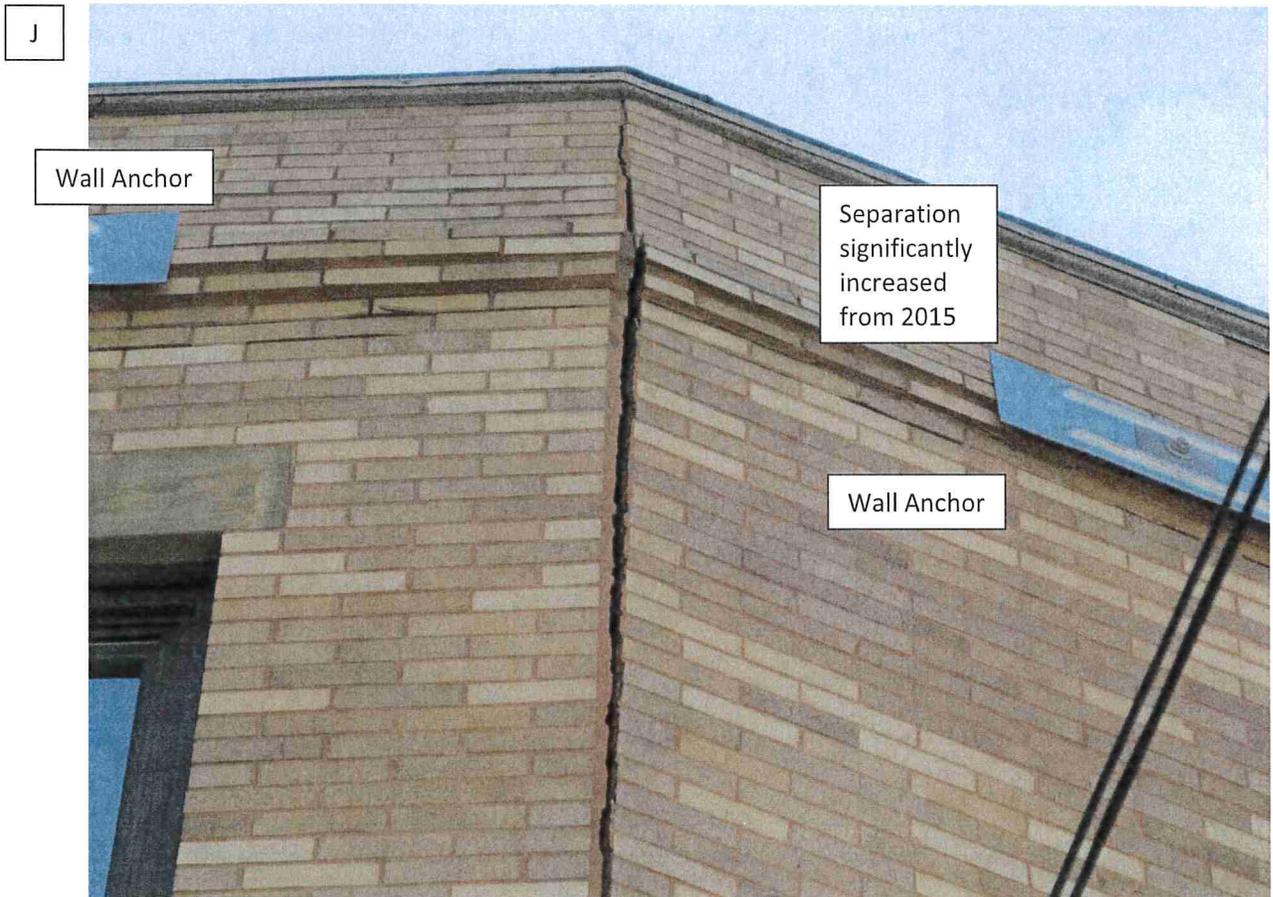
This photograph shows the vertical separation during the March 2019 inspection. The wall anchors were loose at the time of this inspection. Additionally, the decorative ledge on the parapet is considerably worse than in 2015.

It is recommended that the wall anchor company return and tighten these rods. The bolts should not be tightened as to pull the façade inward, but just to reaffirm the support. The dangers relating to this condition are slightly less than that of the east wall. Given the fact that the anchor plates are in place, the parapet and façade is not likely to fall in large sections. Any failure and falling bricks would be more likely localized and not protrude as far away from the building. That being said, the sidewalk and parking lane in this area along Roslyn Street should be barricaded off.

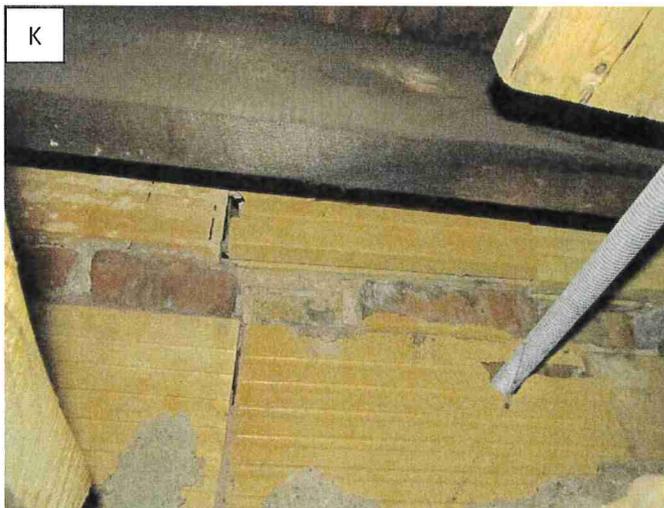
The brick was drilled and an all-thread rod connects the outer plate with the inner plate. This was installed in 2017 by a wall anchor company.

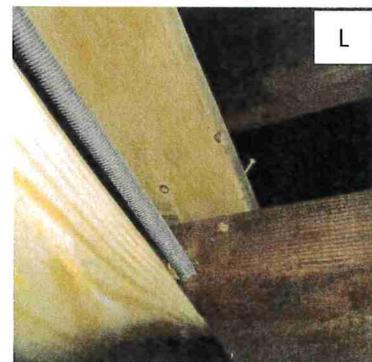
The threaded rod passes through four (4) roof joists that are attached to each other with two (2) 2x6 wood members. Although all four members share the lateral load applied by the rod tension, there is a propensity for wood members under constant stress to slowly “creep” and move in the direction of the forces applied. It should also be noted that there are three (3) additional anchors and rods applied to these same four joists. At the time of the 2019 inspection, the bolt on the rod shown above was loose and was able to be hand tightened for approximately two (2) revolutions. The bolt may have been worked loose by lateral movement of the façade and/or roof wood members.

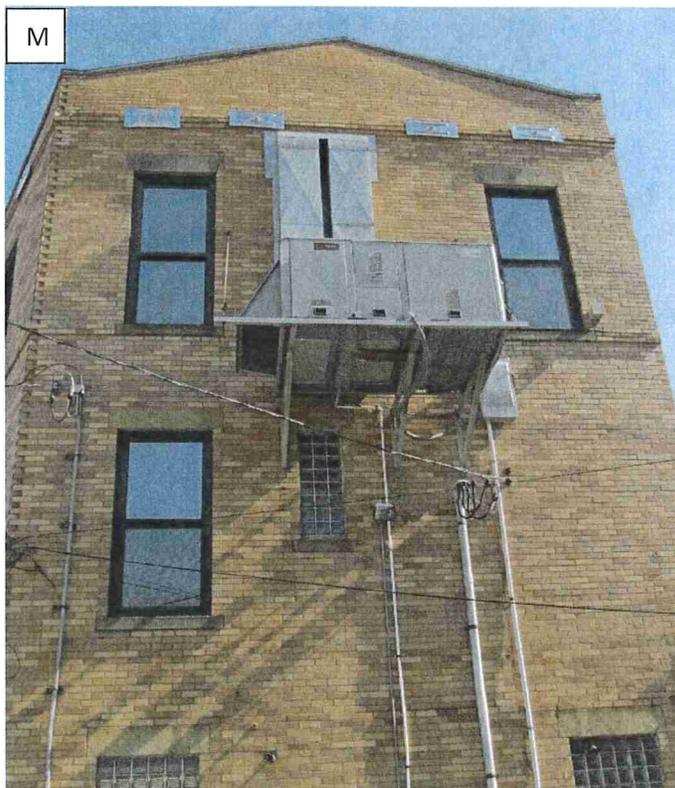
A large HVAC unit is attached to the south wall with three (3) supports underneath and two (2) cables above at a 45° angle to the wall. As shown below, the façade above the anchors is distorted and leaning in several directions. It is not known at this time exactly how this structure was anchored to the building. It is not clear whether the HVAC unit is impacting the façade given what can be visually seen, therefore the conditions of this structure are questionable. Although the area below is not open to the public, valuable equipment and employees should not be allowed on this side of the building.

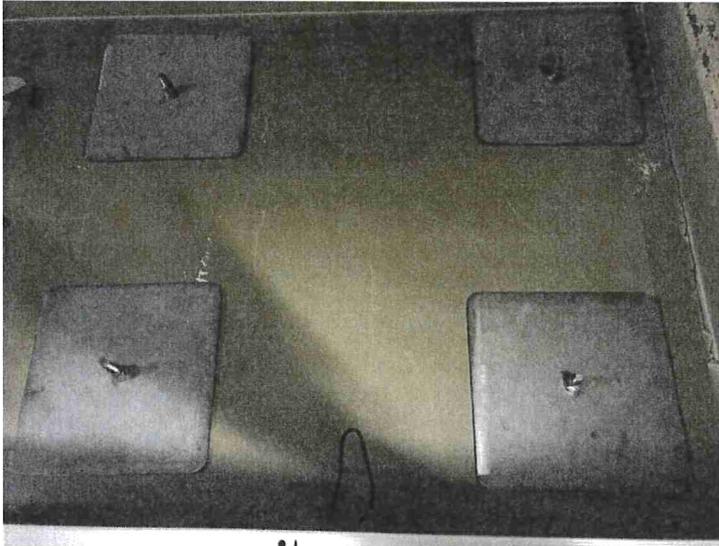
This photograph depicts the lower bracket attachment method of the HVAC unit supports. The

attachment points appear to be stable, however the size of the bolts may or may not be sufficient for the shear forces at the joint. The method for the upper attachment points for the cables is not known for certain. Assuming the methods used are the same as for the lower brackets shown here, structural calculations would need to be conducted to determine the capacity of the attachment point. This unit is still a concern and should be further inspected if the Engineering Drawings for its installation are not available for review.

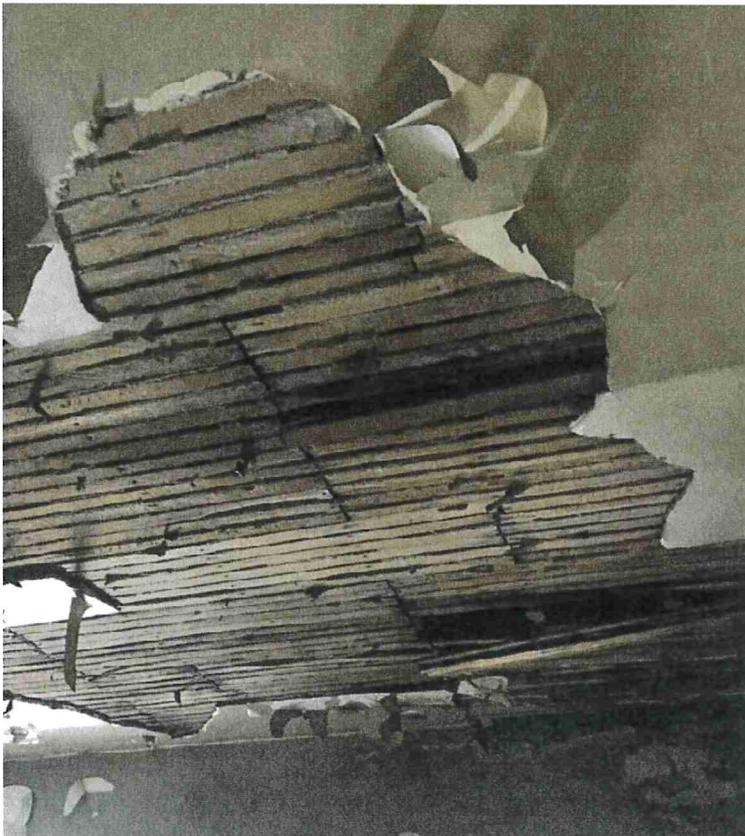
This photograph depicts the ceiling of the jail cells located on the floor below the Council Chambers. It

appears the condition was caused by water intrusion; however it is not clear where the source of the water is. With the exception of the portion of the ceiling lath hanging down, it appears to be aesthetic. That being said, if the roof is sagging, additional inspections would be necessary. This condition should be monitored over time for signs of further damage.
