KU Resources, Inc.

Subject: Assessment of Structural Failure
Borough Building
7560 Roslyn Street
Swissval, Allegheny County, Pennsylvania

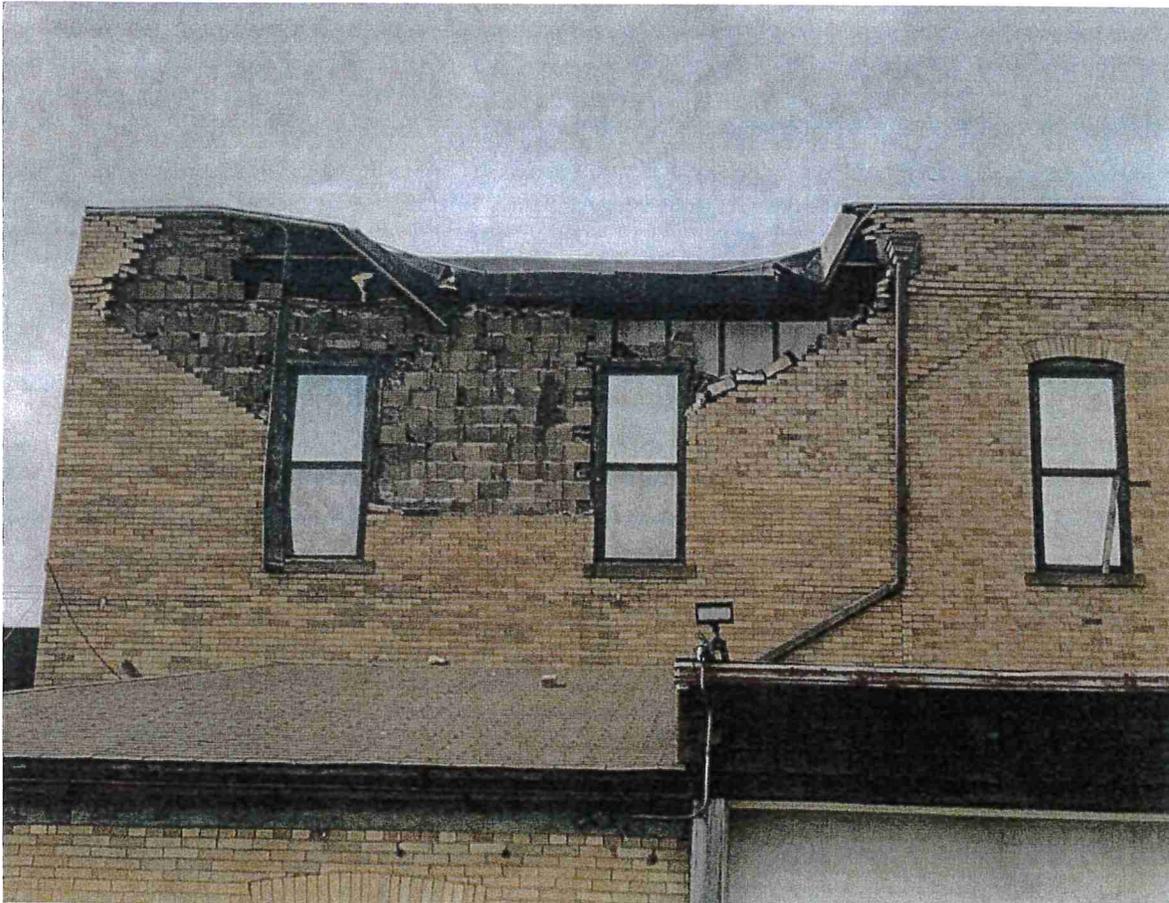
KU Resources, Inc. (KU Resources) is pleased to provide you with the following report of the structural condition of the Borough Building in light of the wall failure that occurred on the afternoon of March 26th. On that date, the southeastern wall of the upper floor, outside of the Council Chambers, failed and collapsed through the roof of the Public Works Garage below. An approximate 40 foot long section of the wall collapsed, as shown in the photograph below.

The failure involved not only the brick façade of the building, but also the underlying vitrified clay block used in the construction in about 1935. The roof structure in this area appears to be presently supported by the framing structure used to create the interior surface of the Council Chamber. This area of failure is approximately 25 feet and more above the surrounding ground surface at the southern end of this addition.

The damage present reflects a complete structural failure of this building. The missing wall section and unsupported roof are putting undue stress on the remaining two walls of this wing, which have already been stabilized in the past due to known façade issues. ***In my professional opinion, I believe that this situation represents a public safety hazard, which could possibly result in additional property damage and potential loss of life due to its location in close proximity to roadways and occupied structures.***

To abate the situation, I am recommending that the walls and top floor of the 1935 addition be removed before there is a cascade failure of the remainder of this portion of the Borough Building. We are devising a remediation plan that would entail building a new exterior wall across the room, approximately where the current railing is positioned. This is the location of the former exterior wall before this last addition was erected, and has the structural support present in the lower levels to bear this weight. Once the roof and walls of this area are removed, a new truss system will be installed over the existing floor joists of the Council Chambers to create a gabled roof structure to protect the police Offices, jail cells, and storage areas on the lower level.
