Swissvale Municipal Building
Partial Demolition of the Council
Chambers Meeting Room
and
Construction of a Temporary Enclosure

March 30, 2020

May 27, 2020

INTRODUCTION AND CURSORY REPORT

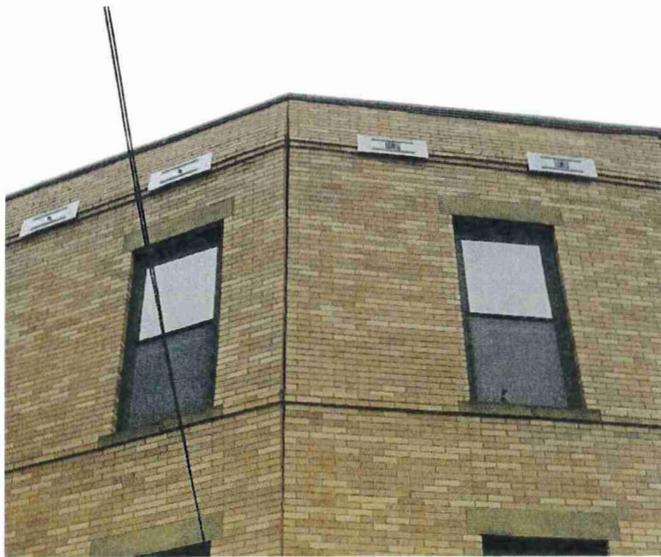
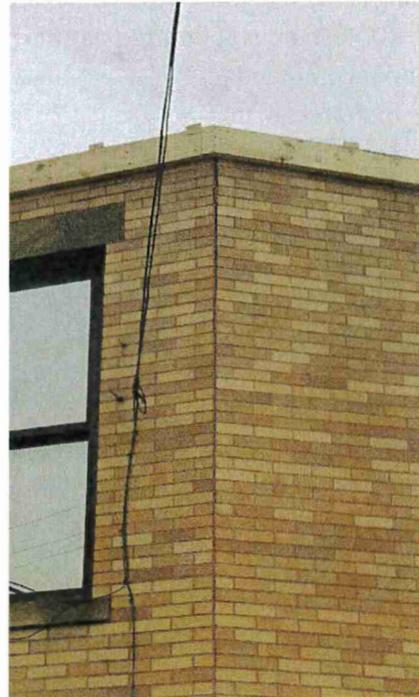
Of primary concern was the remaining portion of the wall below the level of the council chamber floor. Along Roslyn Street a full height vertical crack in a mortar joint shows displacement in the brick façade. See photo on right taken after the demolition. Wall anchors were placed along this wall prior to the collapse. See the photo below.

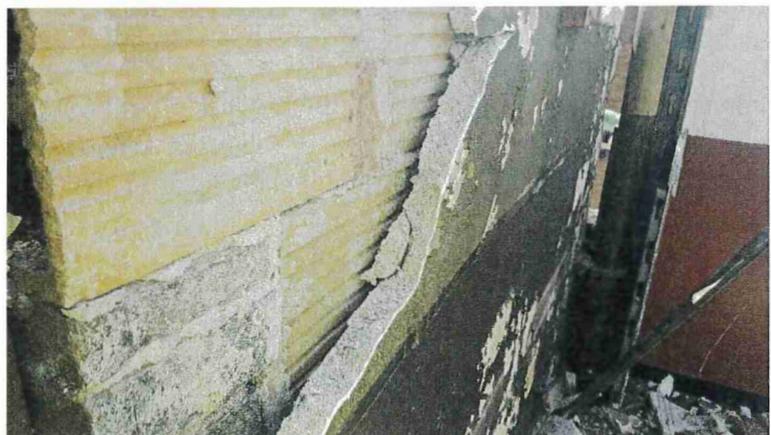
This photo taken during the demolition along the Roslyn Street side shows the result of long-term water infiltration. Here the original plaster covering, which served as the original finished wall shows complete separation from the hollow building tile. This condition was common along the 2nd floor walls. Please refer to the daily reports for pictures and details.

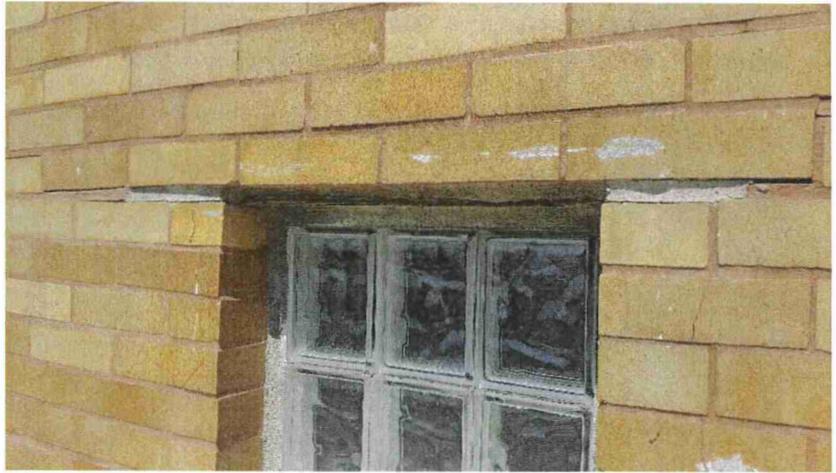
The remaining wall above the public works garage also exhibits structural deterioration. Cracks, step cracking, loss of mortar and vertical displacement are all evident. The photo on the right shows all these conditions.

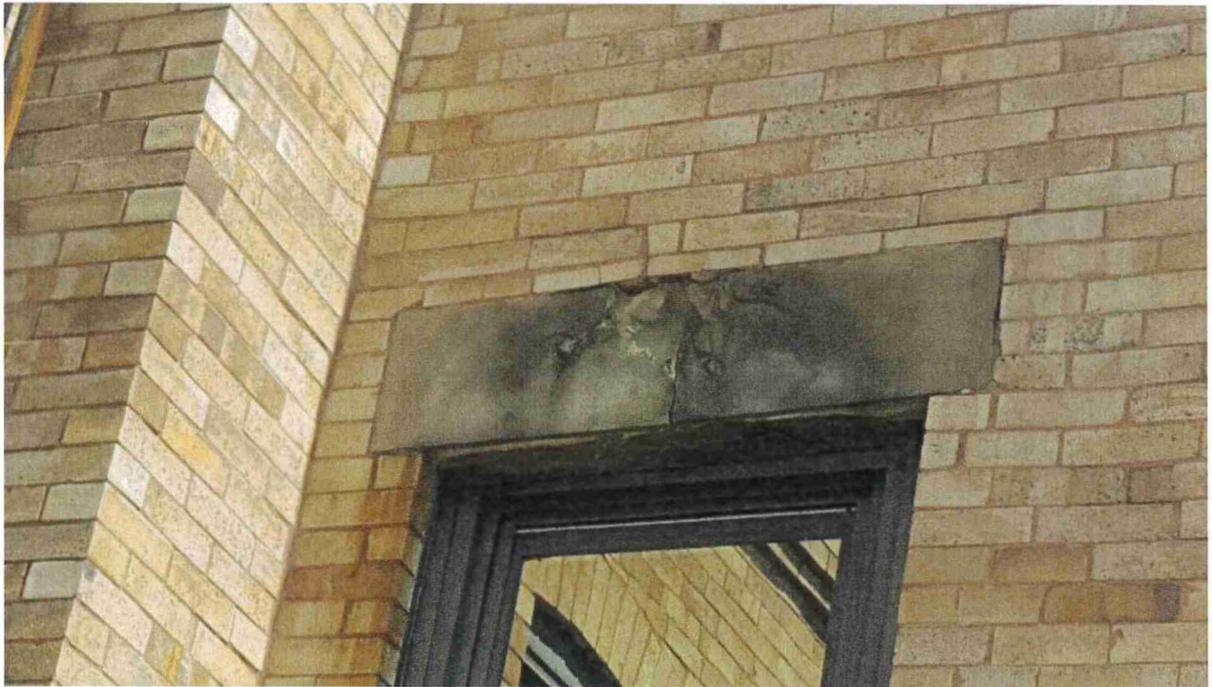
Other parts of the building façade also exhibit distress. The lintel over this window is cracked and displaced.

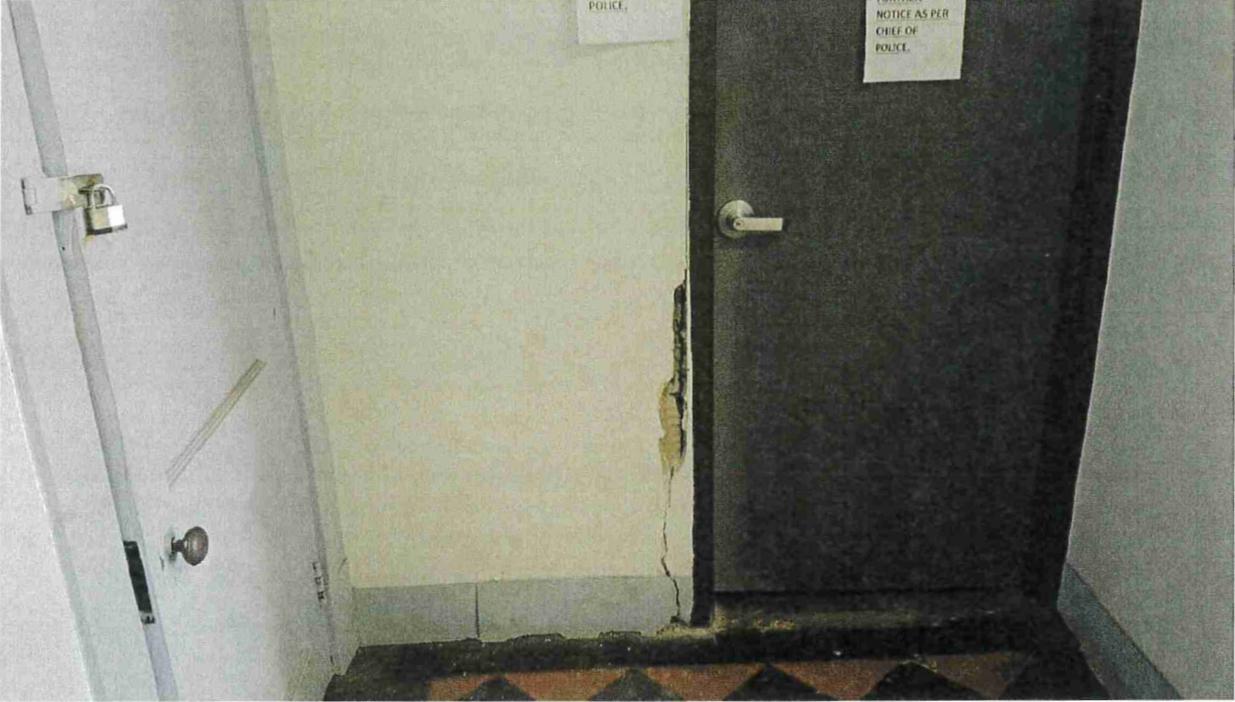
Wall outside of police area

Evidence of water damage is visible in various parts of the building outside of the area that sustained damage in the collapse and subsequent demolition. Some representative areas are shown.

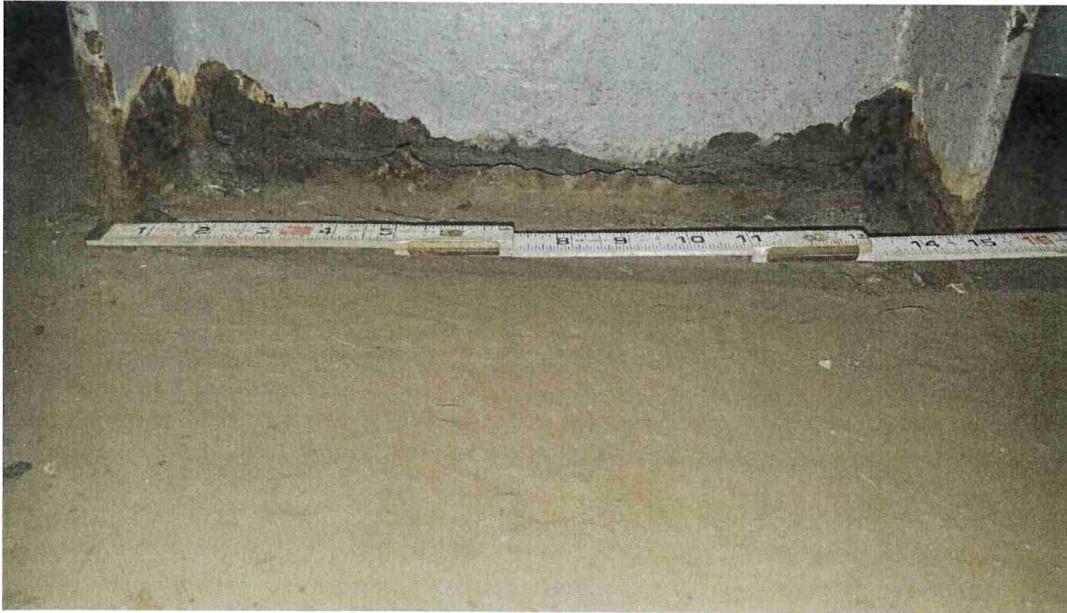
Steel column in boiler room

Other deterioration was noted. Two columns support a floor beam that spans from the garage wall perpendicular to Roslyn Street and extending into the boiler room stopping short of the steps to the main floor. Both columns are I-beams dating to the Jones and Laughlin Steel era. The column in the boiler room exhibits advanced section loss. The web has lost approximately 90% of its section and both rear flanges have lost up to 1/3 of their section. Refer to the following photo.

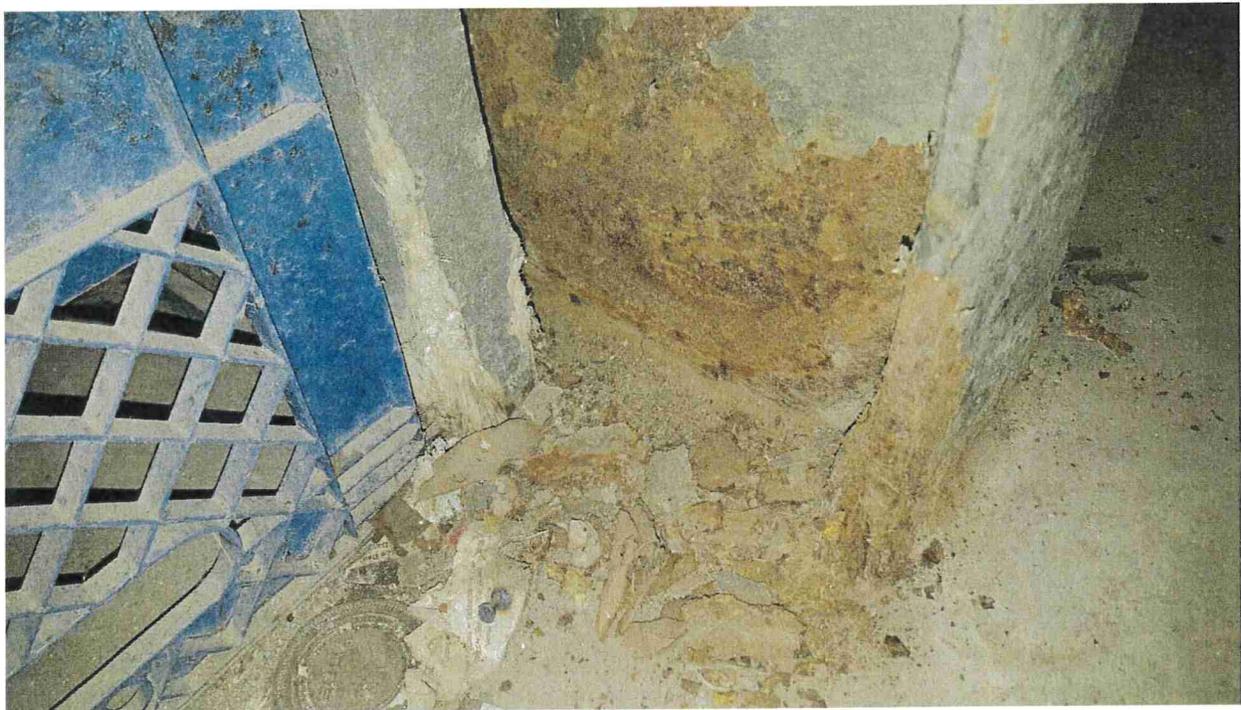
Steel column in public works garage

The column in the garage exhibits rusting and minimal section loss. Refer to the following picture. Deterioration for both columns is occurring at the floor level.

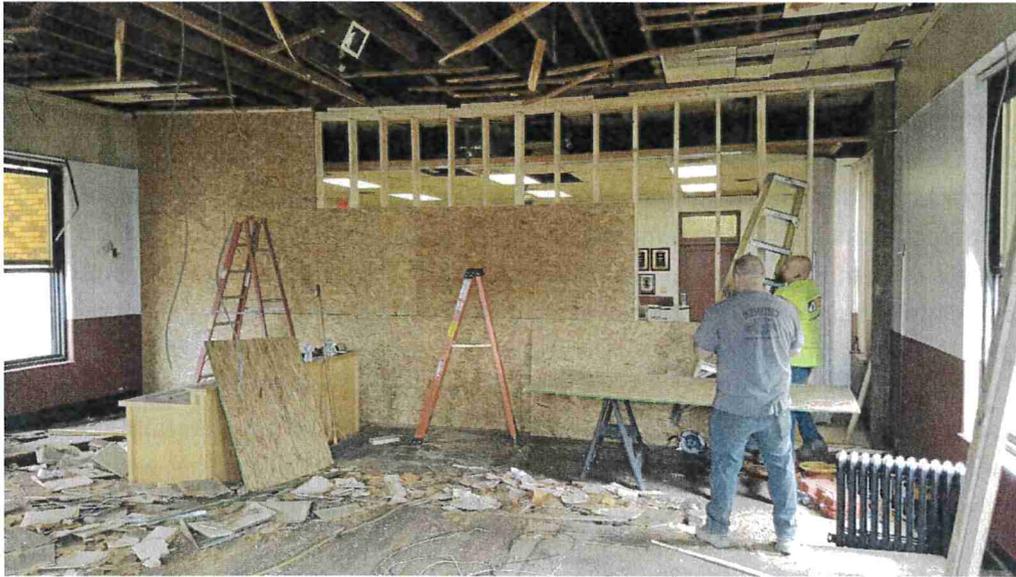
Above the partition wall being constructed is a wooden roof truss. Note the deflection in the truss reflected in the top plate of the partition wall. The top cord of the truss and the steel hanger rod connecting the top and bottom cords have been repaired. The repairs do not appear to be structurally sufficient in nature.

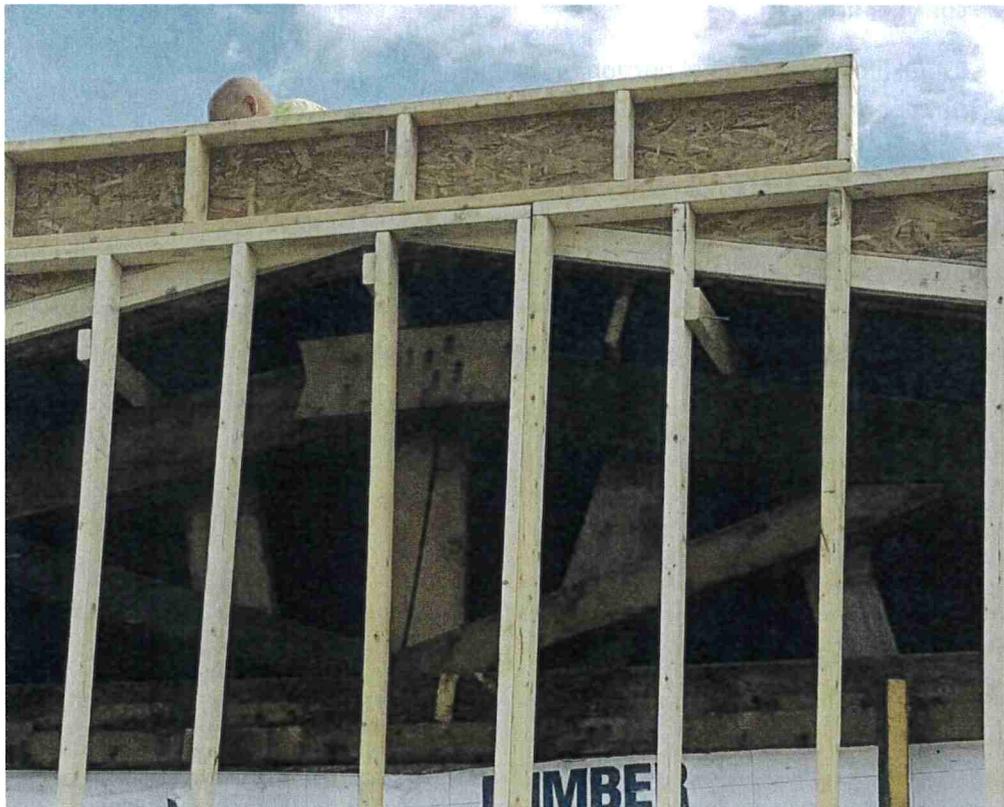
Note top cord repair and displaced hanger rod.

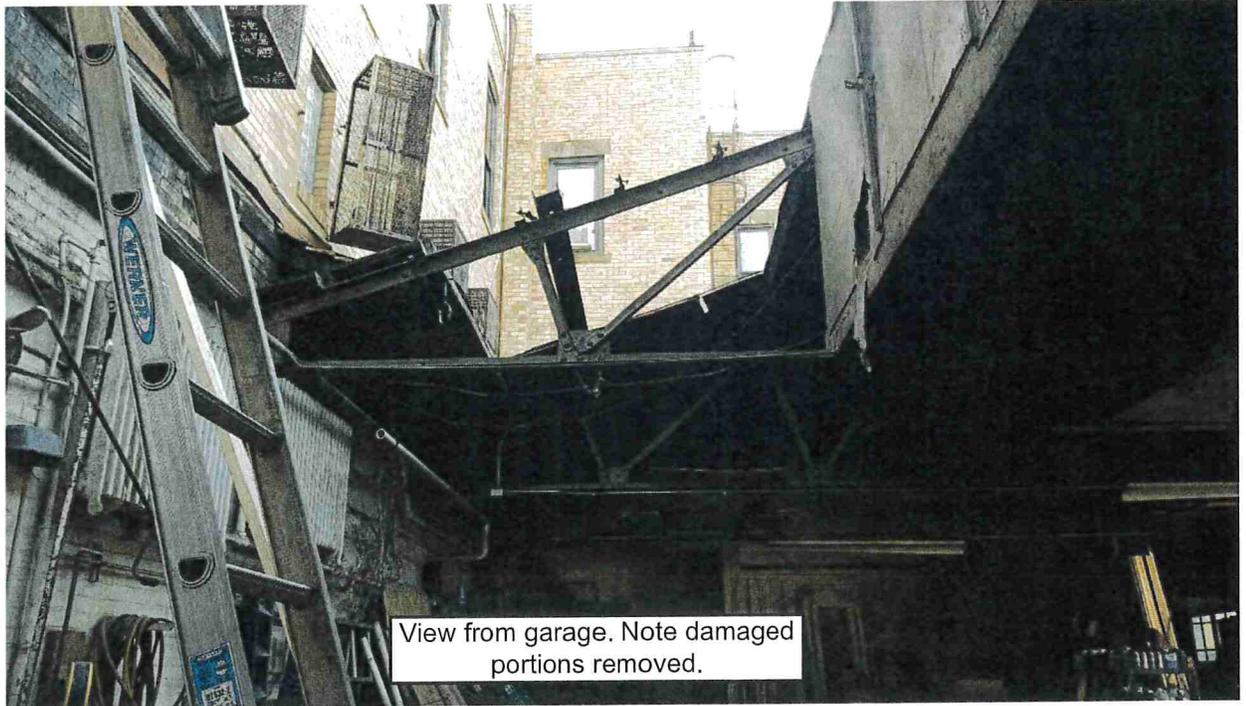
View from garage. Note damaged portions removed.

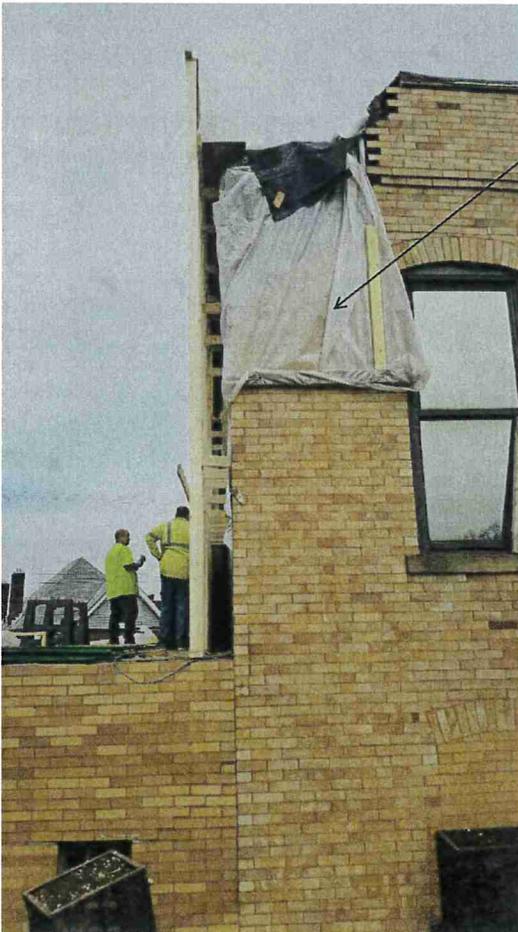
Area of missing brick.

- Duquesne Light on site to re-store commercial power.
- Installed framing and OSB on left to cover exposed area including the missing bricks along the step crack.
- Began removal of window cages.
