Swissvale Municipal Building
Partial Demolition of the Council
Chambers Meeting Room
and
Construction of a Temporary Enclosure

March 30, 2020

May 27, 2020

INTRODUCTION AND CURSORY REPORT

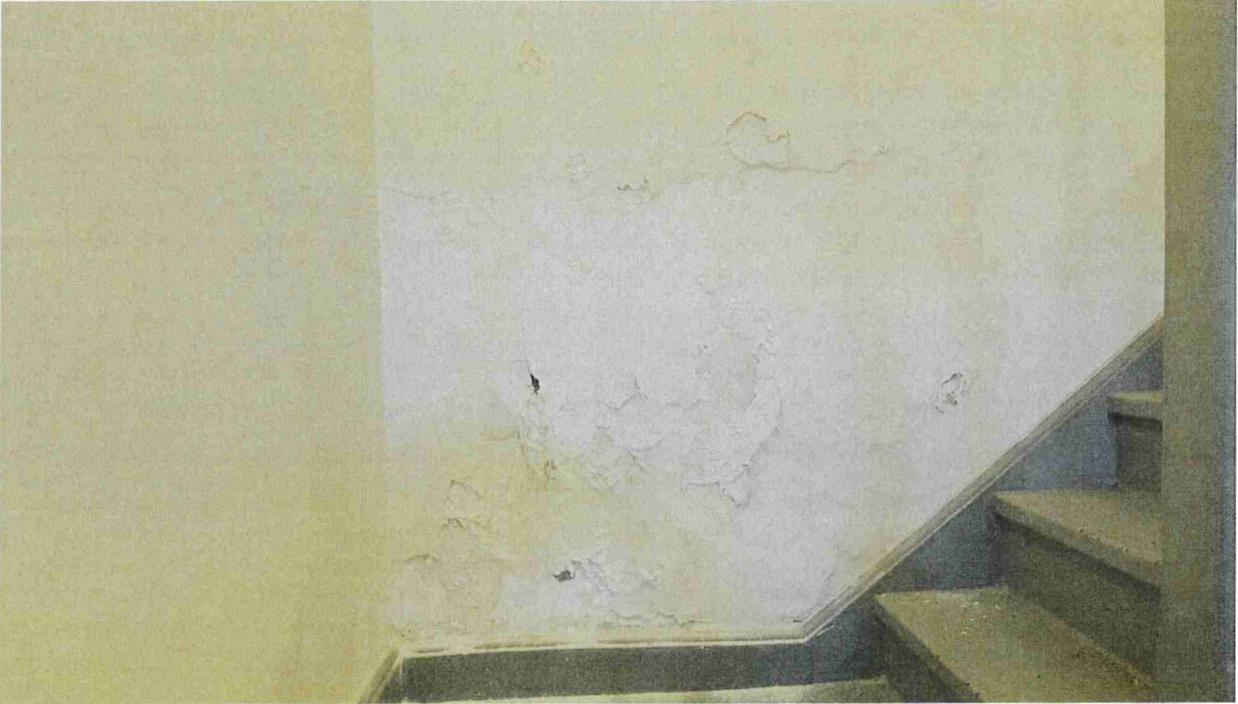
Wall outside of police area

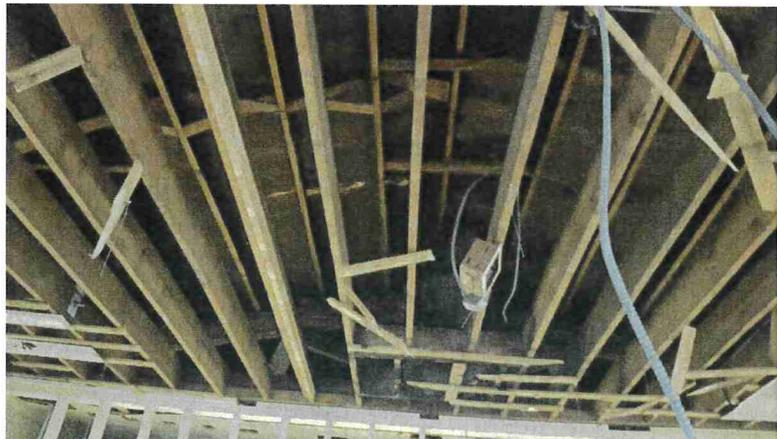
Suspended and original finished ceiling removed.

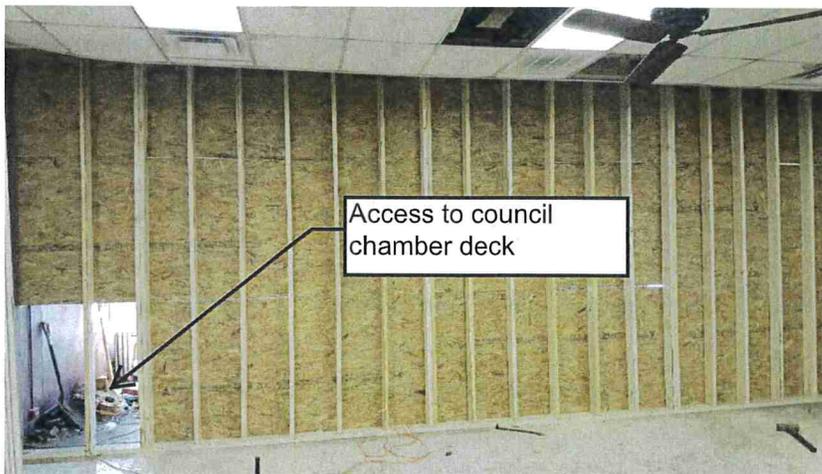
Interior partition wall

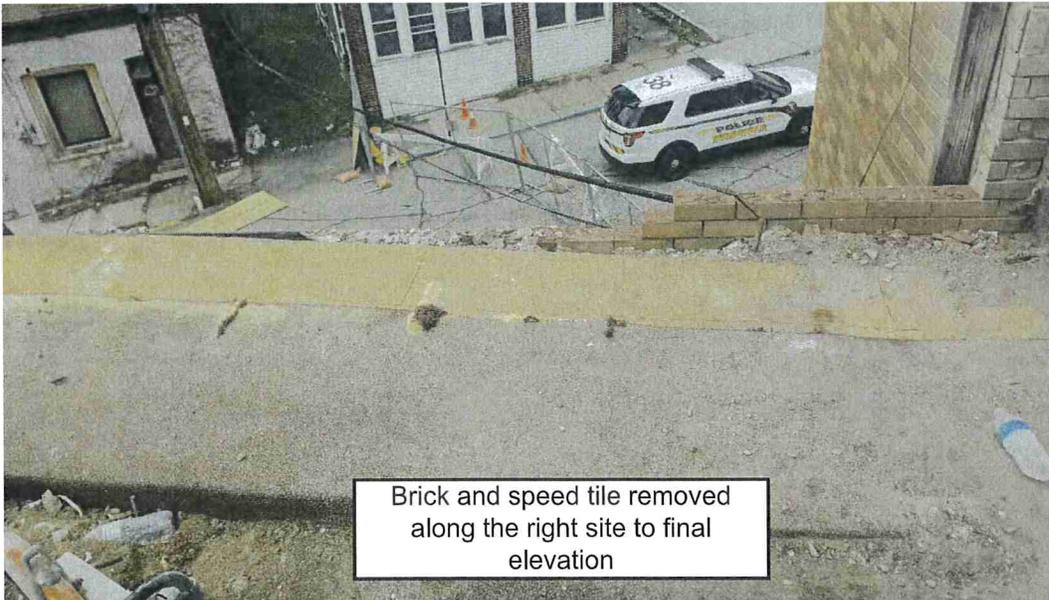
Brick and speed tile removed along the right site to final elevation

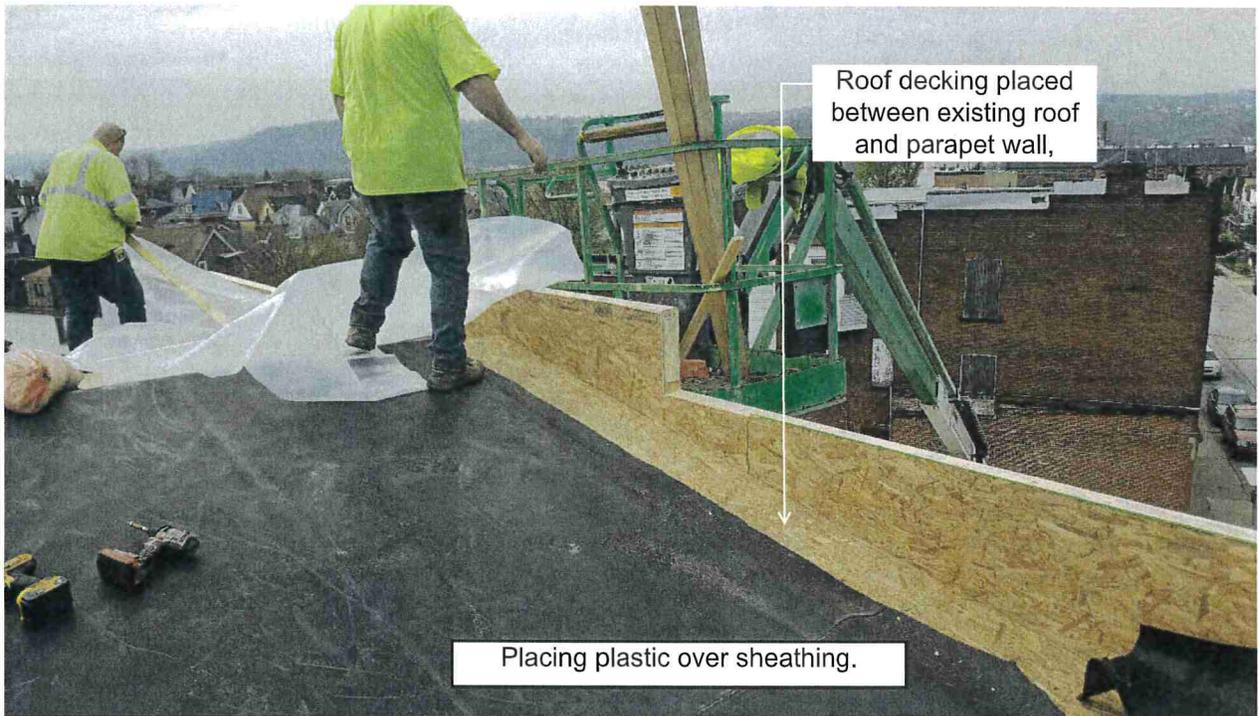
Roof decking placed between existing roof and parapet wall,

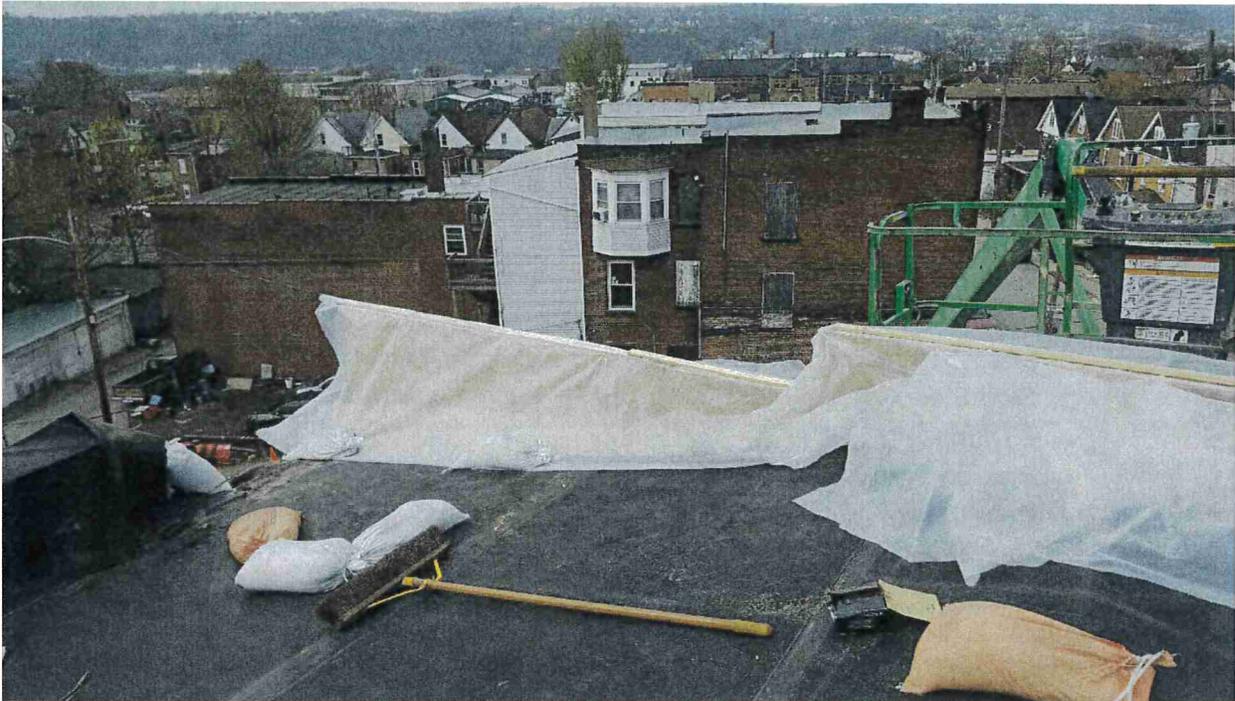
Area of missing brick.

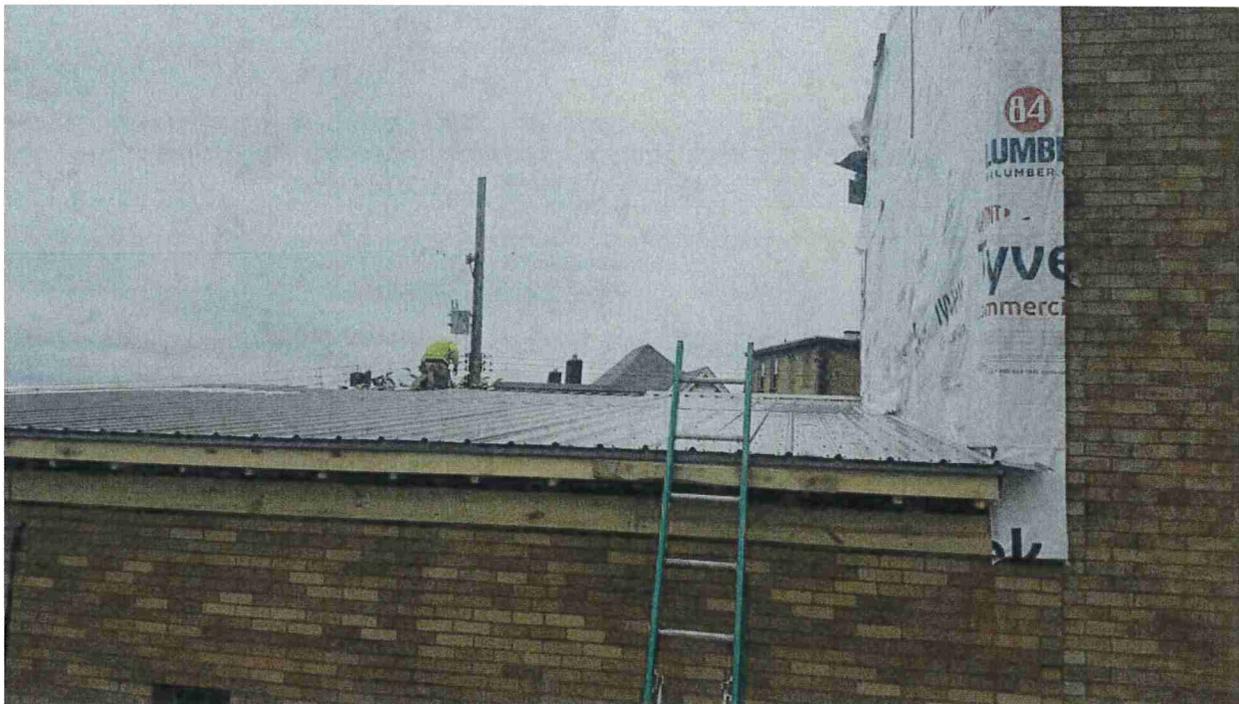
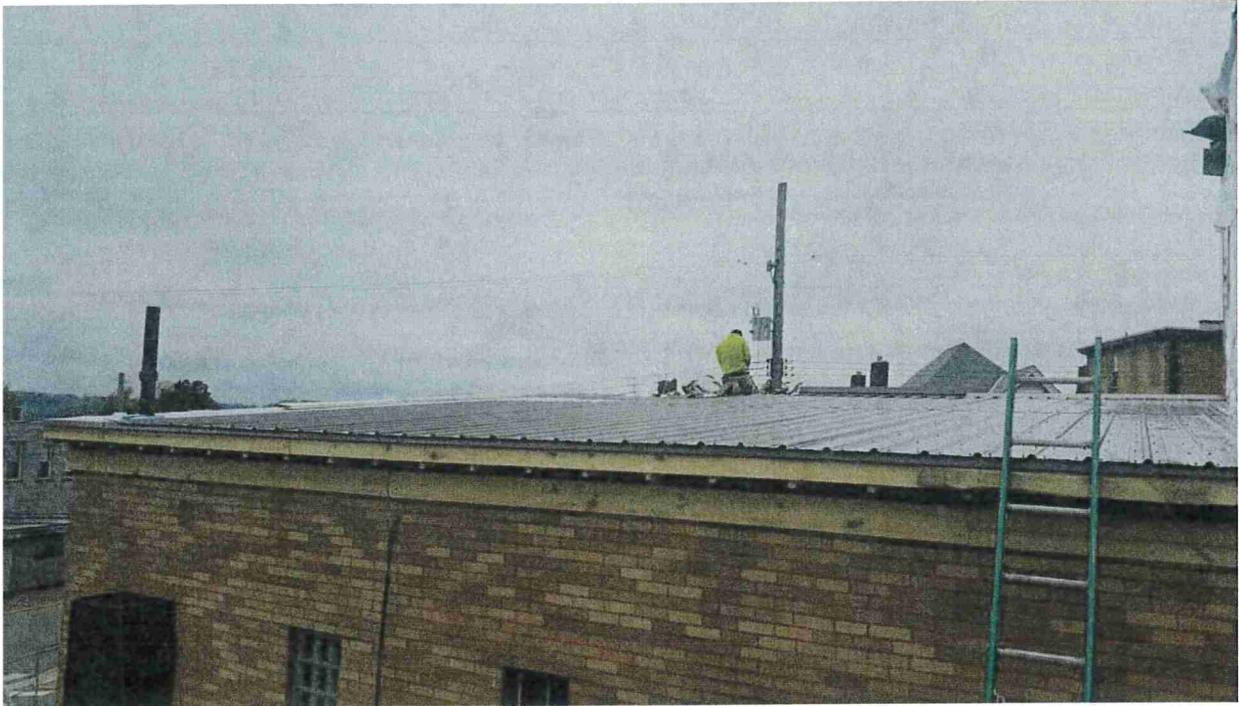
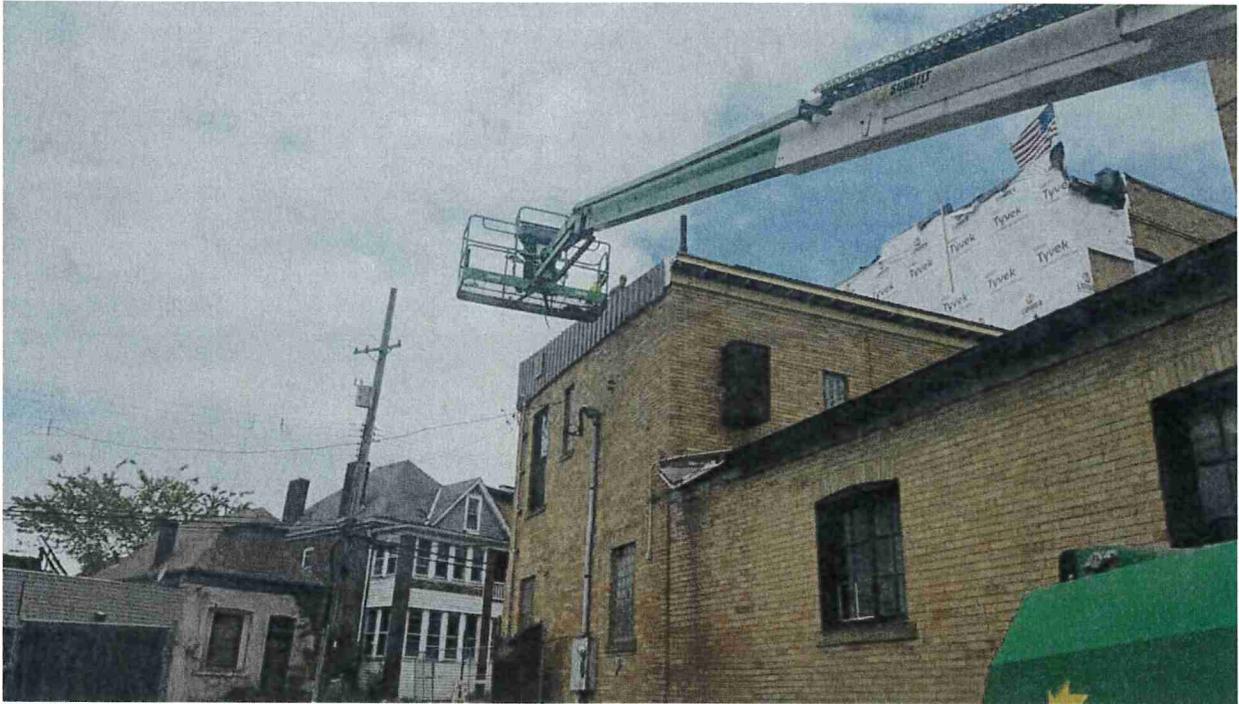
- Applied roofing panels to the fascia.

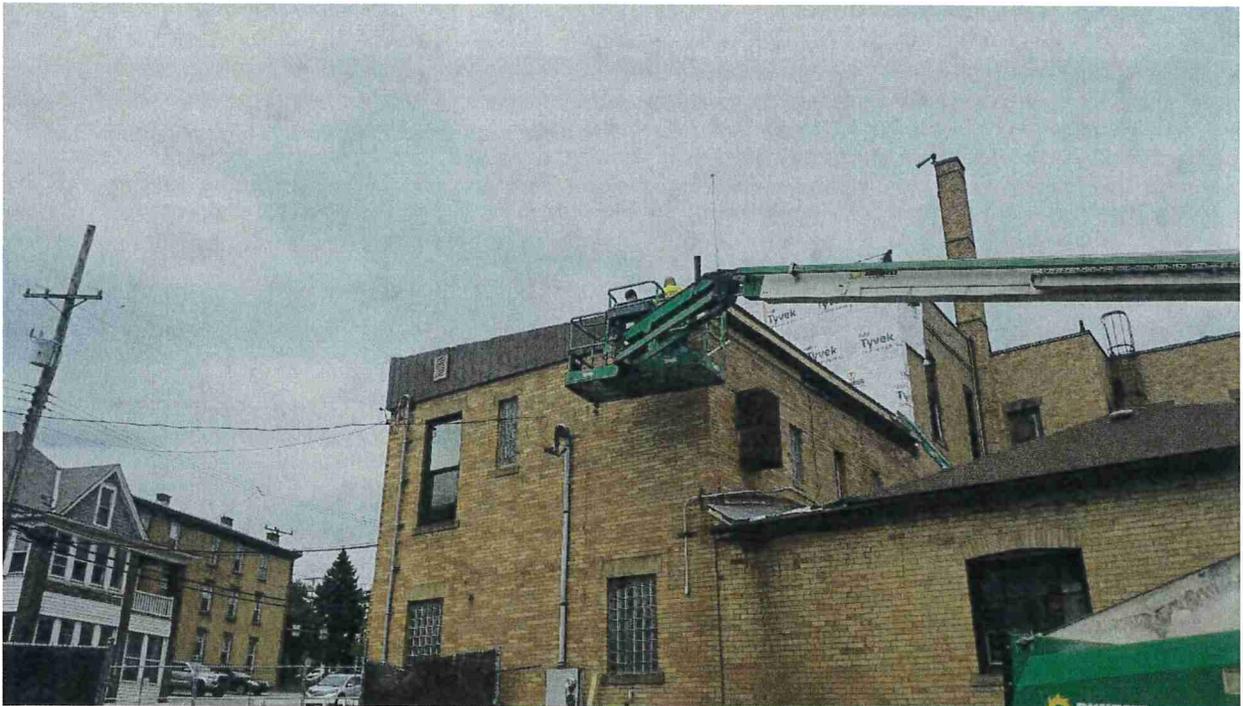
- Contractor waiting on additional and replacement parts for the metal roof.
- Installed fascia along roof overhang.
- Reset panels along street side fascia to correct vertical alignment.
- Drip edge installed along street side fascia.
- KU Resources on site to collect samples for mold. Air samples were collected in the following areas:
 - Police locker room
 - Hallway outside of jail cells.
